CALSPAN ON-SITE AIR BAG DEPLOYMENT INVESTIGATION

CALSPAN CASE NO. 91-08

VEHICLE - 1991 FORD TAURUS

14. Sponsoring Agency Code	
15. Supplementary Notes On-site investigation of an air bag deployment crash that involved a 1991 Ford Taurus. The 35 year old female driver was wearing the active belt system improperly and impacted the left A-pillar, sustaining fatal head injuries.					
<p>16. Abstract This report focuses on a 1991 Ford Taurus that rotated in a clockwise direction and impacted a W-beam guardrail with its frontal area. The crash resulted in a sufficient longitudinal deceleration which closed the crash sensors and deployed the vehicle's driver air bag system. Damage to the vehicle was minimal (2" of residual bumper crush); however, guardrail damage was extensive with 28.5" of crush to the strong post system.</p> <p>The driver of the Ford Taurus was a petite 35 year old female who was wearing the 3-point lap and shoulder belt improperly with the shoulder belt webbing positioned under her left arm. She was slightly out of position to her left at impact due to the pre-crash CW rotation of the vehicle. At impact, she initiated a forward and lateral trajectory to her left in

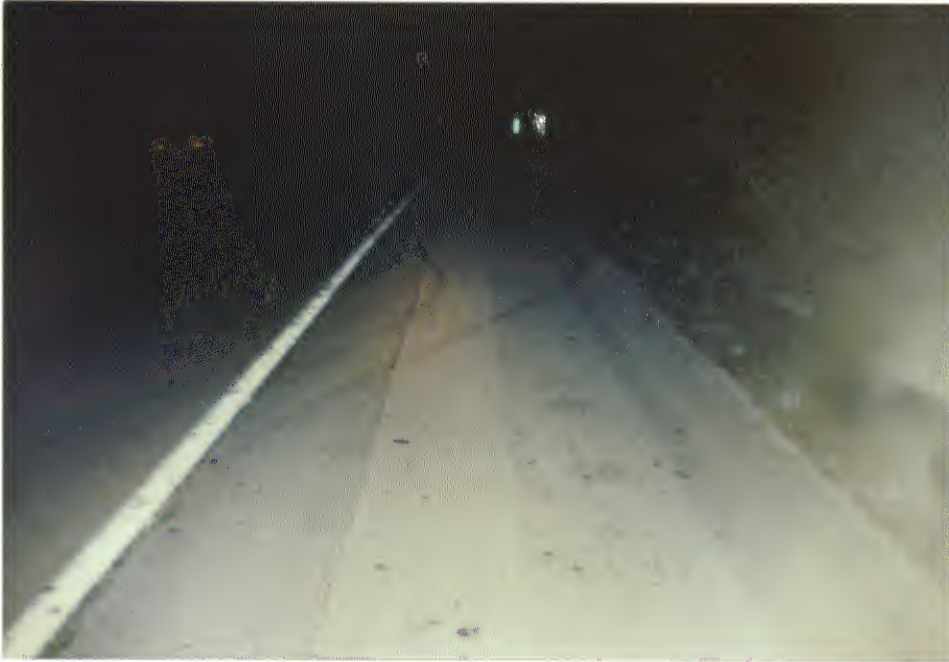
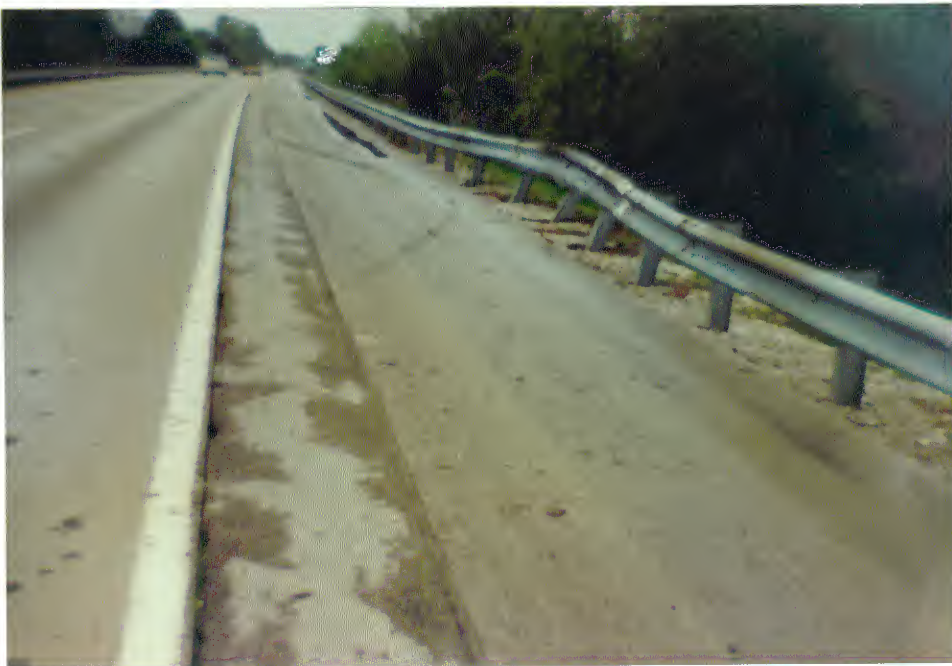
Pre-Crash Clockwise Yaw Marks From The Ford Taurus.

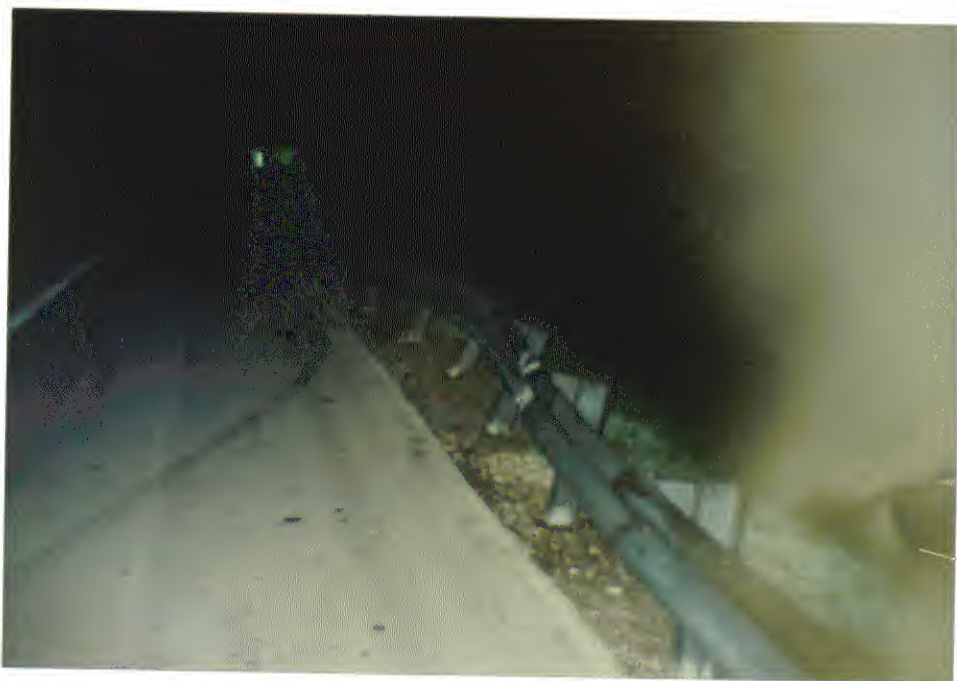
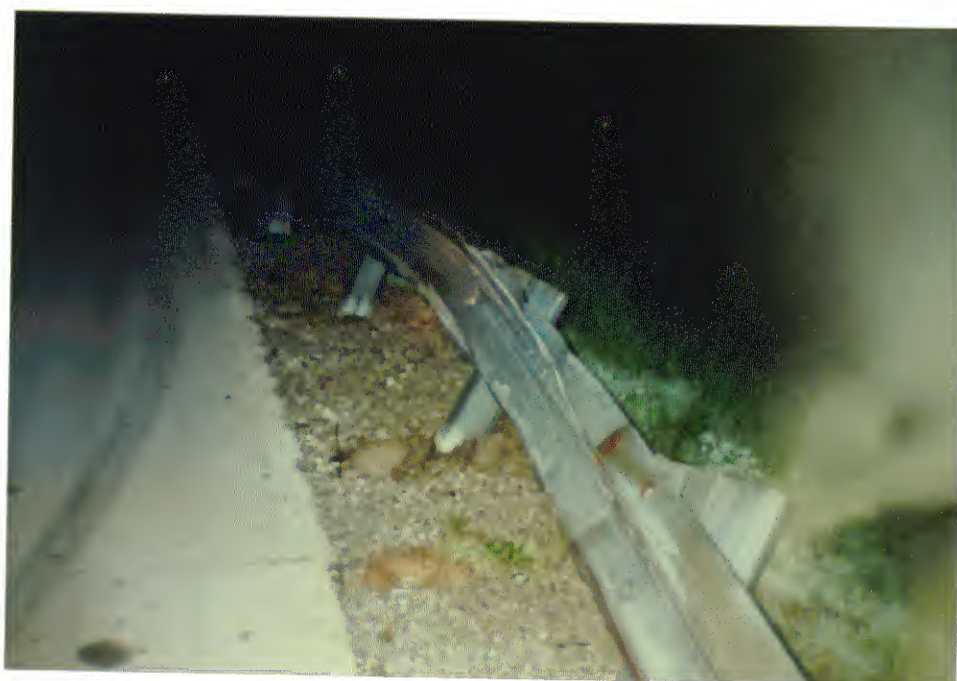
Deployment Impact Sequence With The W-Beam Guardrail.

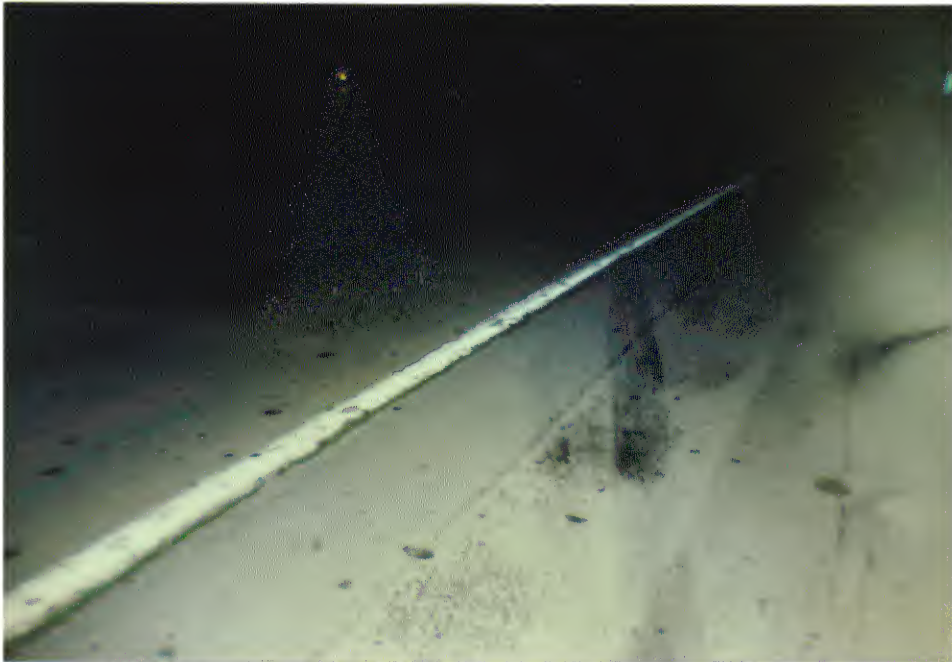
Separation Trajectory And Continued Clockwise Rotation Of The Ford Taurus.

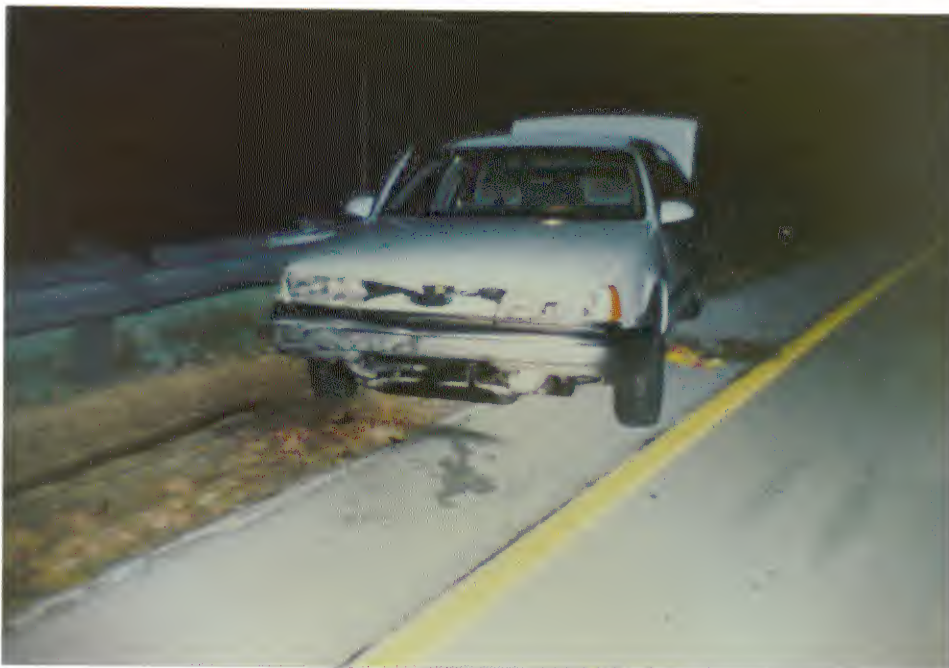
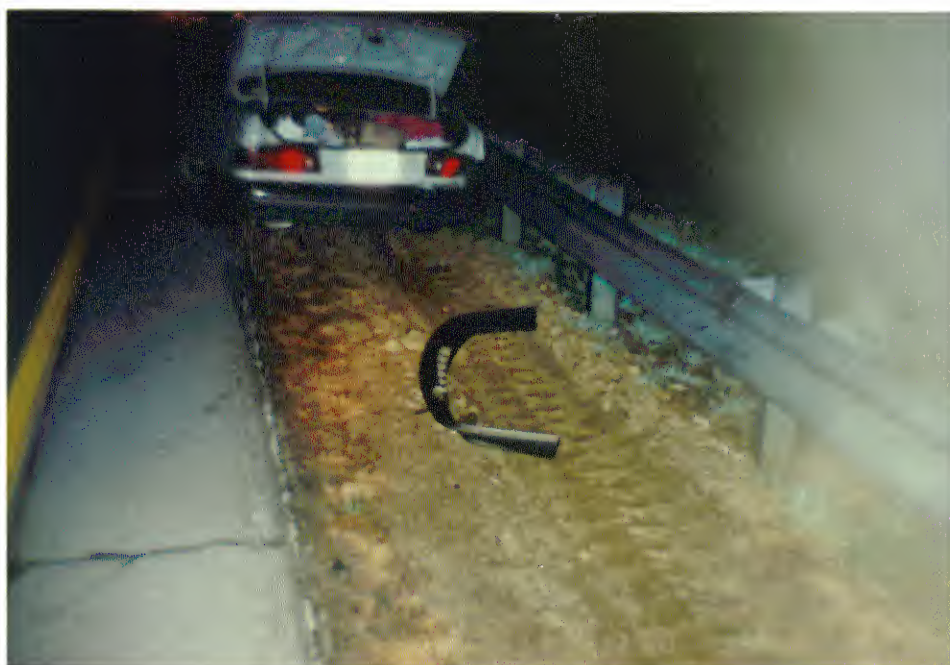
Secondary - The right rear area of the Ford Taurus impacted the median W-beam guardrail as the vehicle rotated across the travel lanes. Direct contact damage on the rear bumper began 17.5" right of center and extended 12.6" to the right rear corner area. Although no residual bumper crush occurred (no EAD compression) as a result of the impact, the right taillamp area of the vehicle engaged with the guardrail resulting in 4" of sheetmetal crush at the right rear corner.

Secondary Guardrail Impact And Final Rest Position  
Of The Ford Taurus.

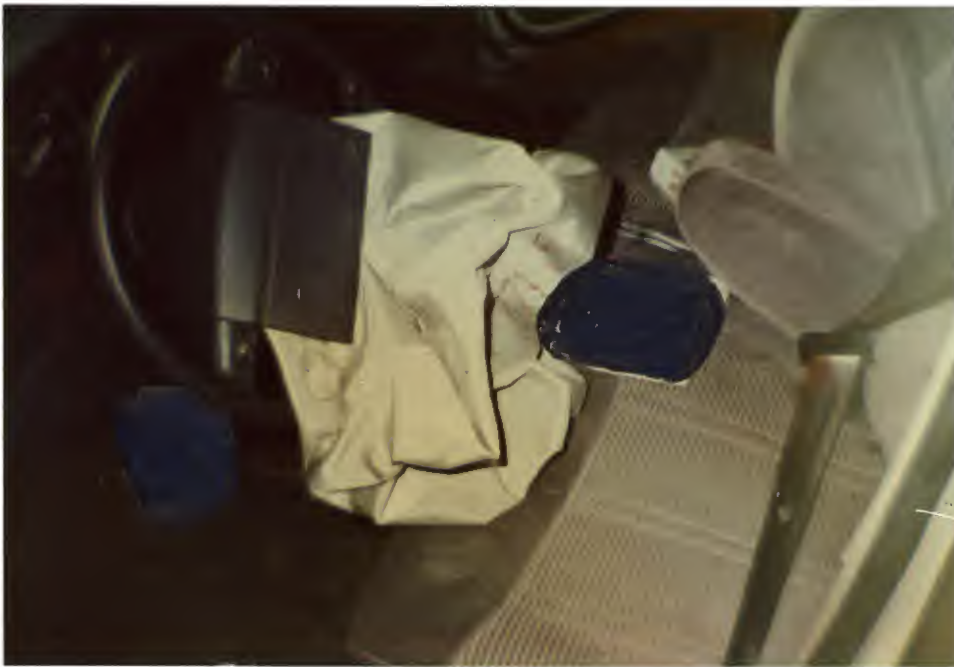
Closeup View Of The Upper Module Cover Flap.

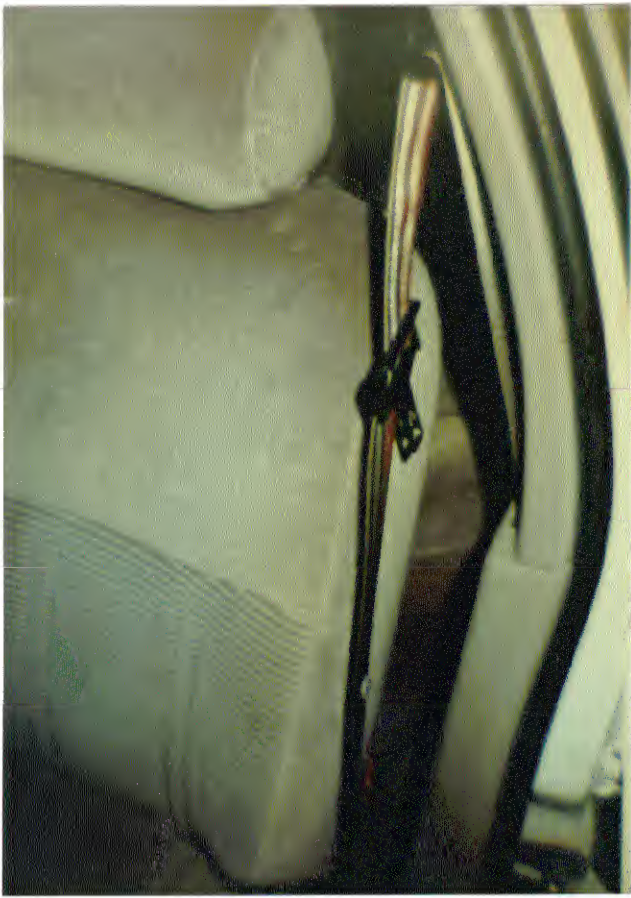
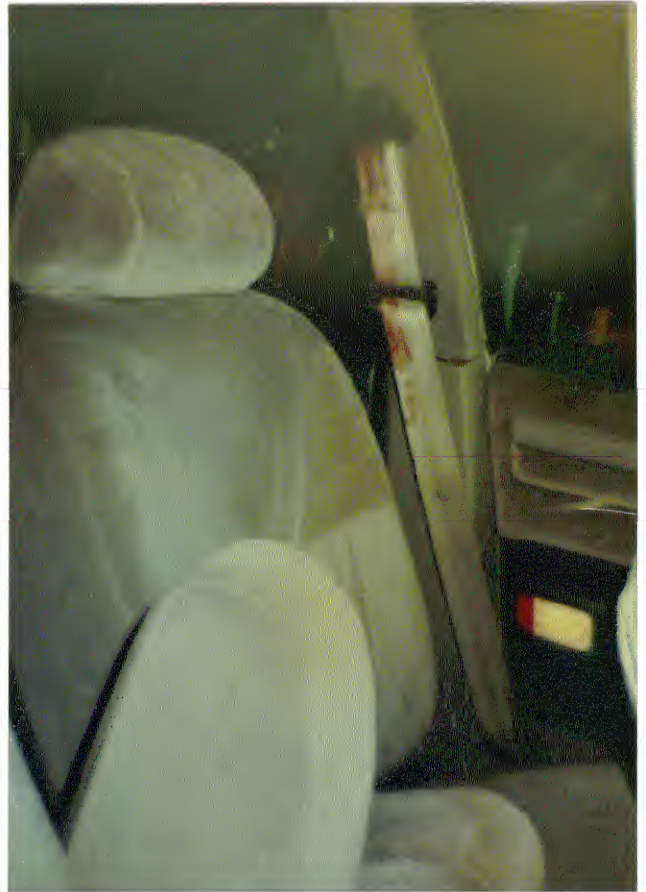
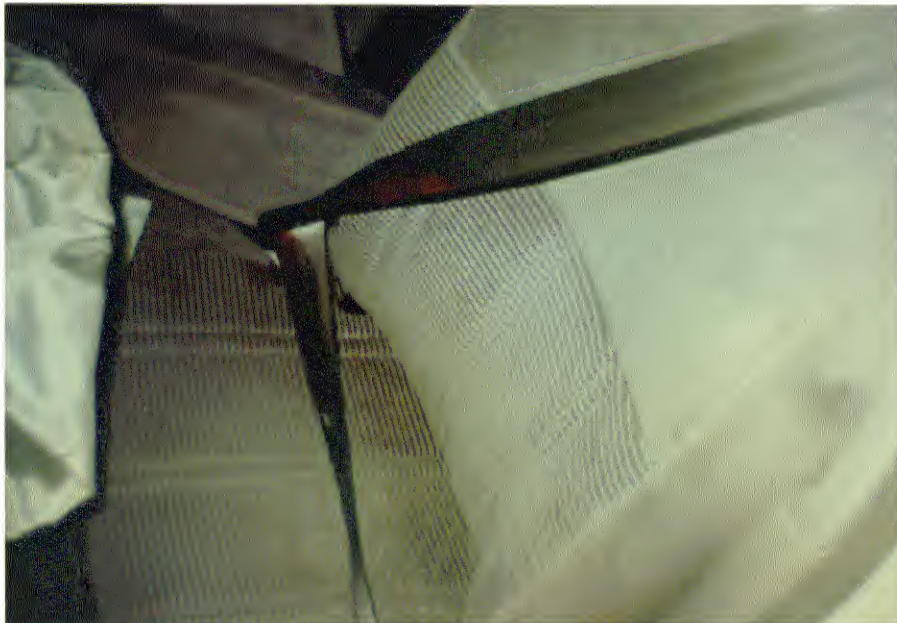
The driver rebounded into the left front seatback then slumped forward where she came to rest. The head injuries produced bleeding from her left ear and nose. Blood stains were visible on the air bag and the shoulder belt webbing in the vicinity of the latchplate.

Blood On The Belt Webbing In The Area Of The Latchplate.

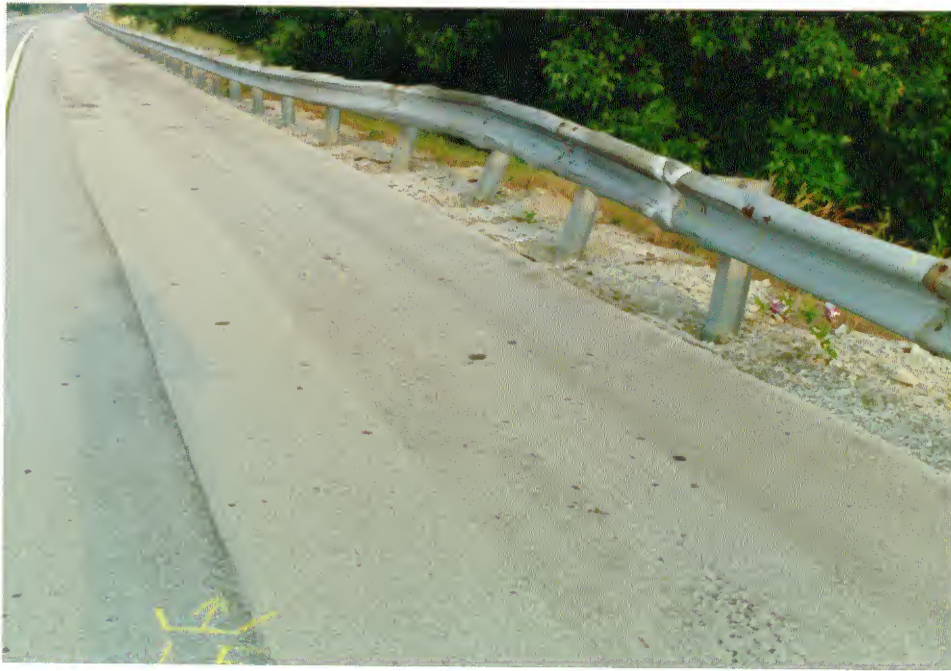
Left Front Tire Mark On Asphalt Shoulder.

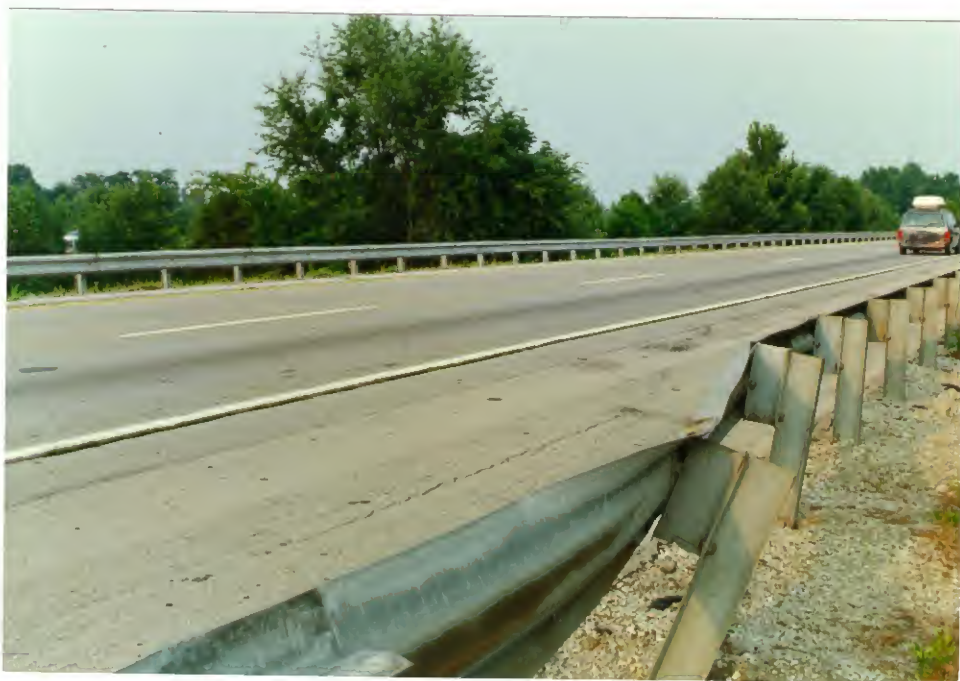
Vehicle Separates From Guardrail And Crosses Travel Lanes  
Rotating In A CCW Direction.

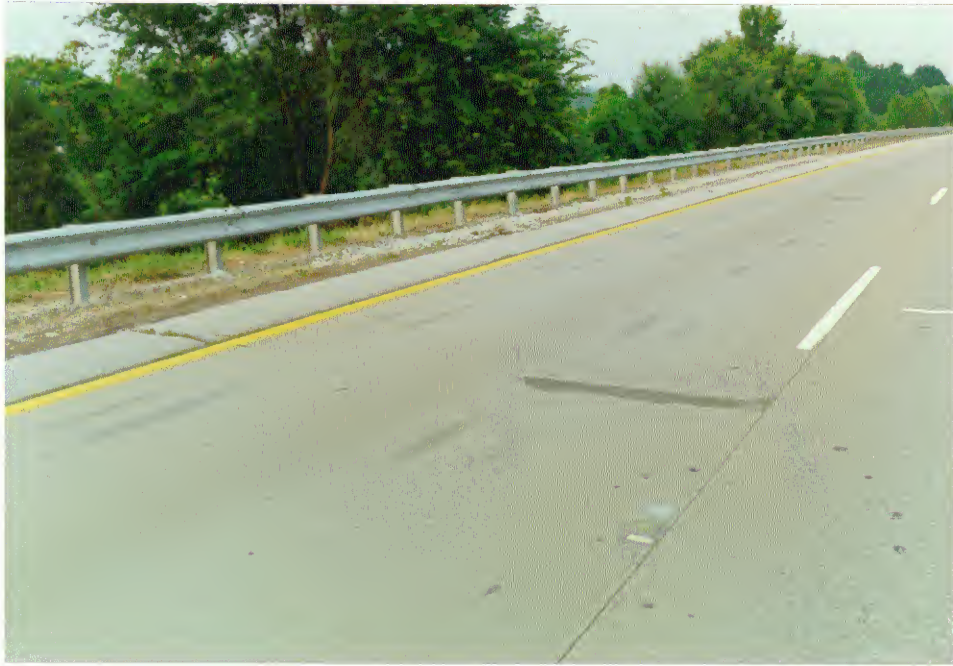
Rotational Trajectory Of Vehicle En Route To Secondary Guardrail Impact.

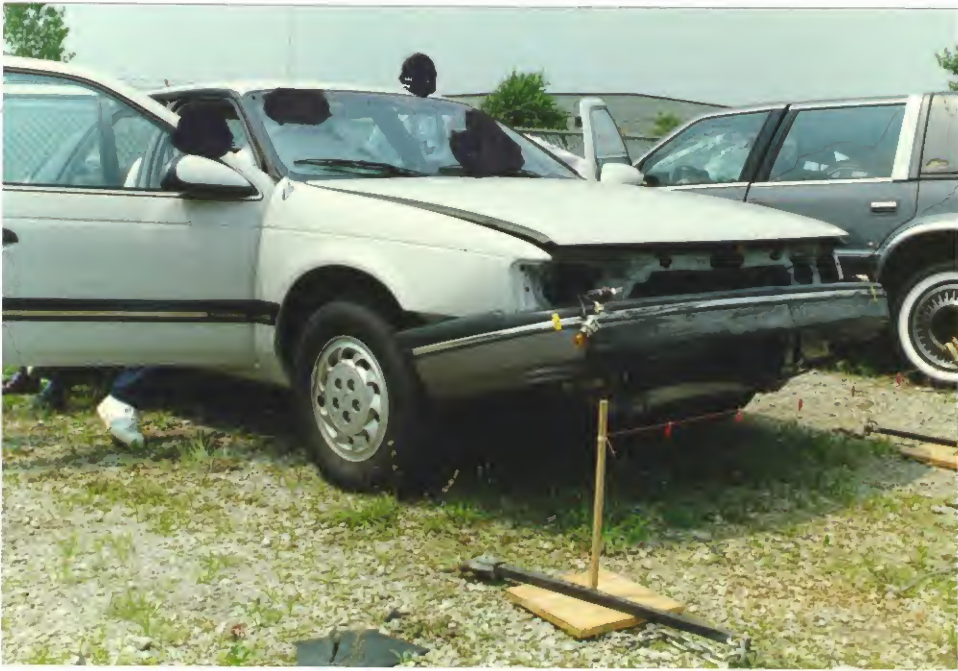
Right Front Three-Quarter View.

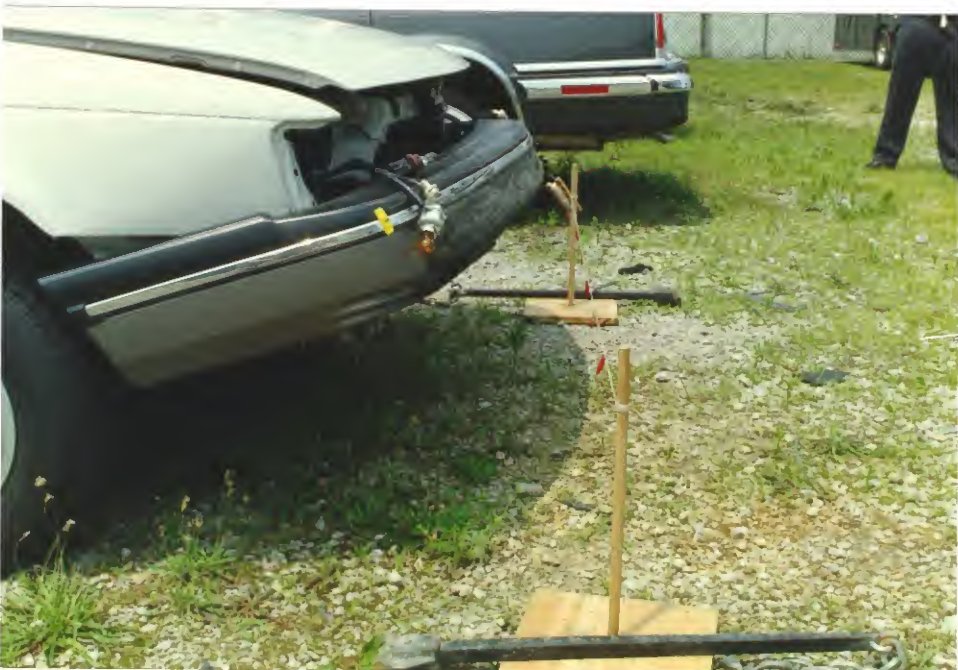
Primary - The frontal area of the Ford Taurus impacted a W-beam guardrail which resulted in minor damage to the bumper and adjacent components. Maximum crush was 2.0" that was located at the right corner of the bumper. Direct contact damage on the bumper face began 22" left of the vehicle's center line and extended 52.4" to the right corner. The impact compressed both bumper energy absorbing devices (EADs) which resulted in a combined induced and direct contact damage length of 60.25" that involved the entire bumper. The left bumper EAD compressed 0.4" while the right unit compressed 1.6". Both EADs returned to their original pre-crash positions. Crush values were measured at six equally spaced increments across the front bumper and were as follows:  
C<sub>1</sub>=0", C<sub>2</sub>=0", C<sub>3</sub>=0", C<sub>4</sub>=0.1", C<sub>5</sub>=1.0", C<sub>6</sub>=2.0".

Perpendicular View From The Right Front Corner Area  
Showing The Extent Of Crush.

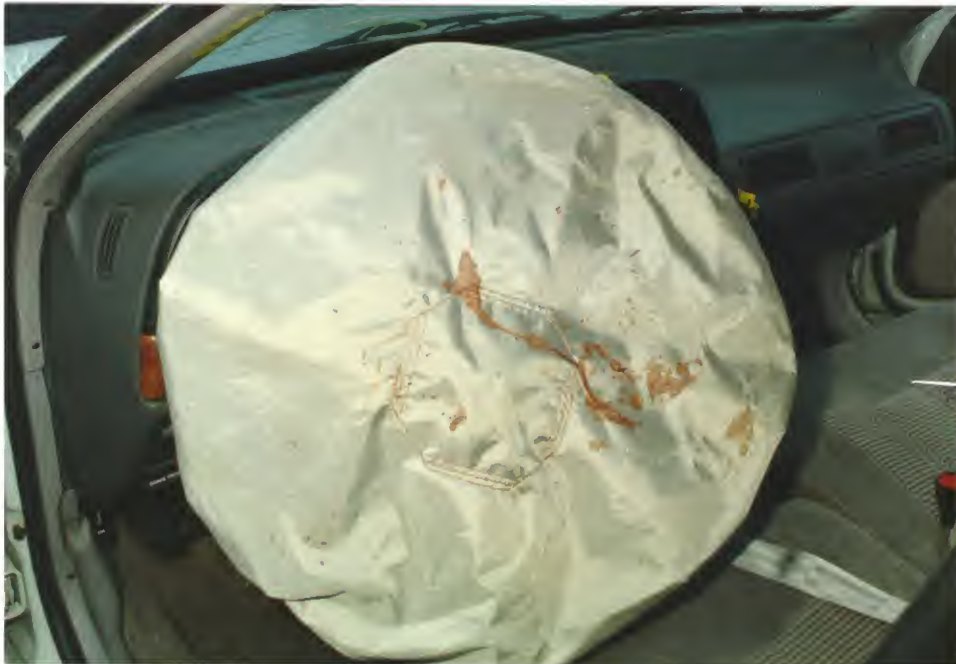
Driver Air Bag.

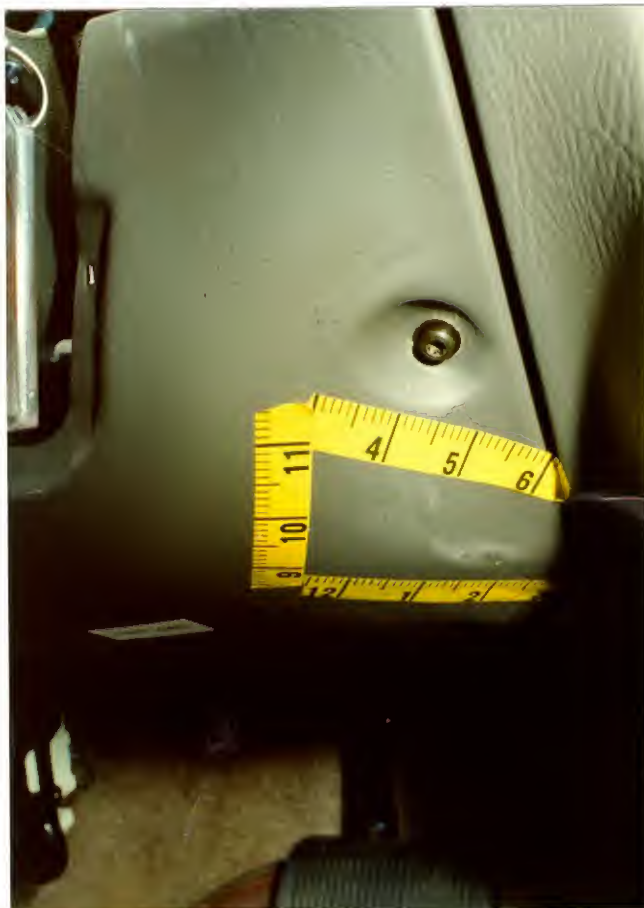
Driver's Left Facial Contact  
To Left Upper A-Pillar.

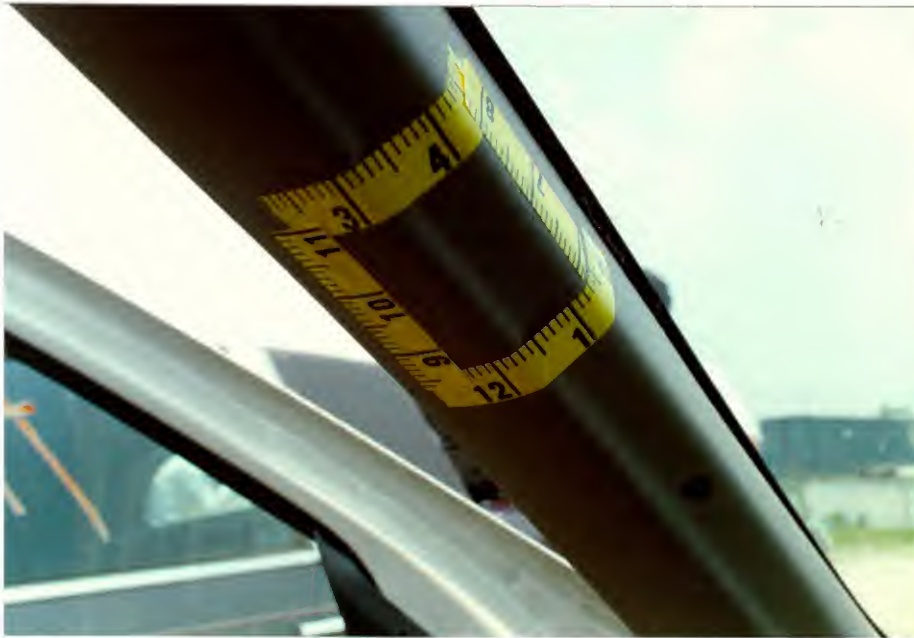
Closeup View Of The Faint Tissue Transfer On Left A-Pillar.

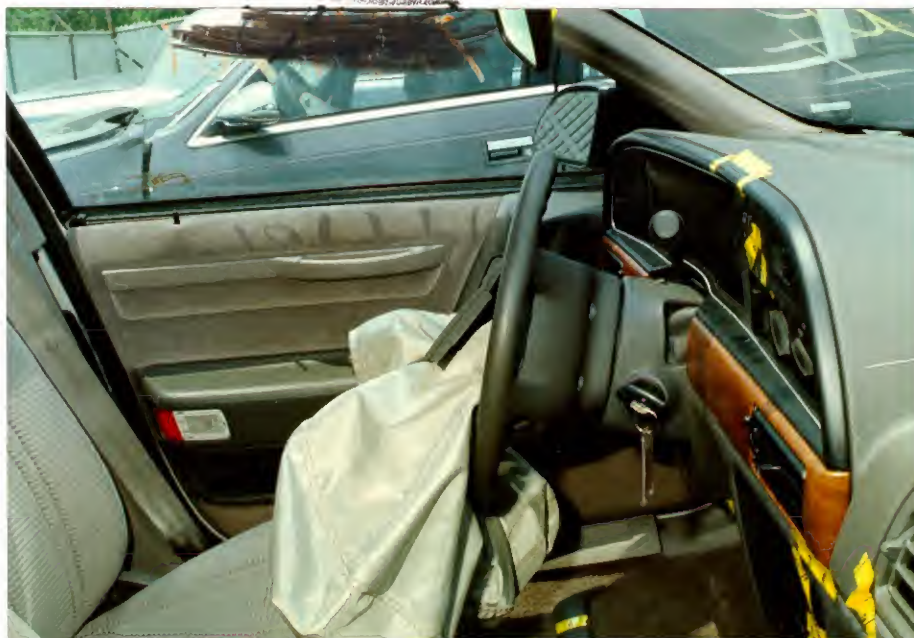
The interior of the Ford Taurus sustained minor damage that was associated solely with occupant contact. The driver's thoracic area loaded the steering assembly through the air bag and deformed the upper steering wheel rim 0.75" forward. Her loading force was transmitted into the steering column which compressed the energy absorbing steering column 1.1". The driver's involvement with the steering assembly fractured and deformed the right cruise control switches that were located between the upper and lower spokes, adjacent to the air bag module. Her knees contacted the steel knee bolster 7-8.25" and 13.9-15.1" left of center. Although no residual damage occurred to the bolster, scuff marks identified the contact areas. The driver's left facial area impacted the mid left A-pillar. Again, no residual damage occurred to the pillar; however, tissue transfers evidenced the contact area. Blood stains were noted to the face of the deployed air bag and on the active belt webbing in the area of the latchplate.

Deformation To The Upper Steering Wheel Rim From Driver Loading.

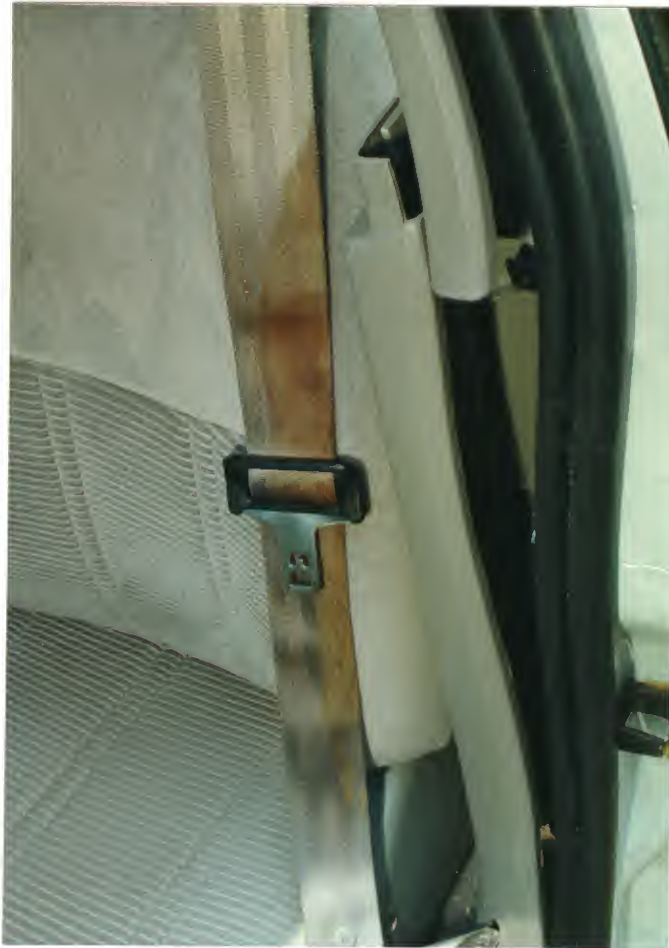
Blood On The Belt Webbing.

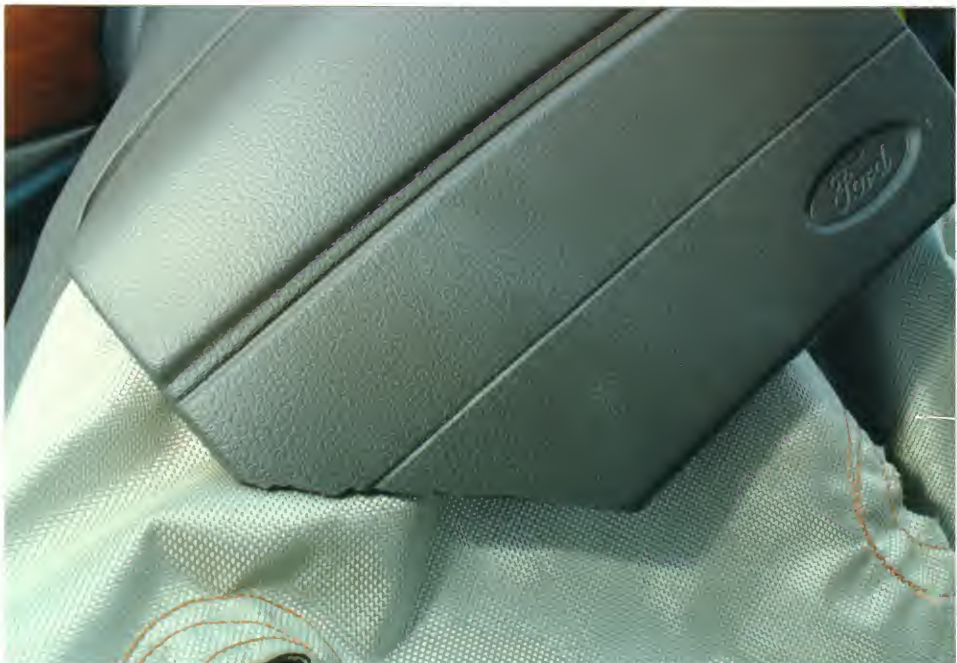
Powder Transfers On Air Bag Module Cover,  
Left Lower Corner Of Flap Had Been Cut Away.

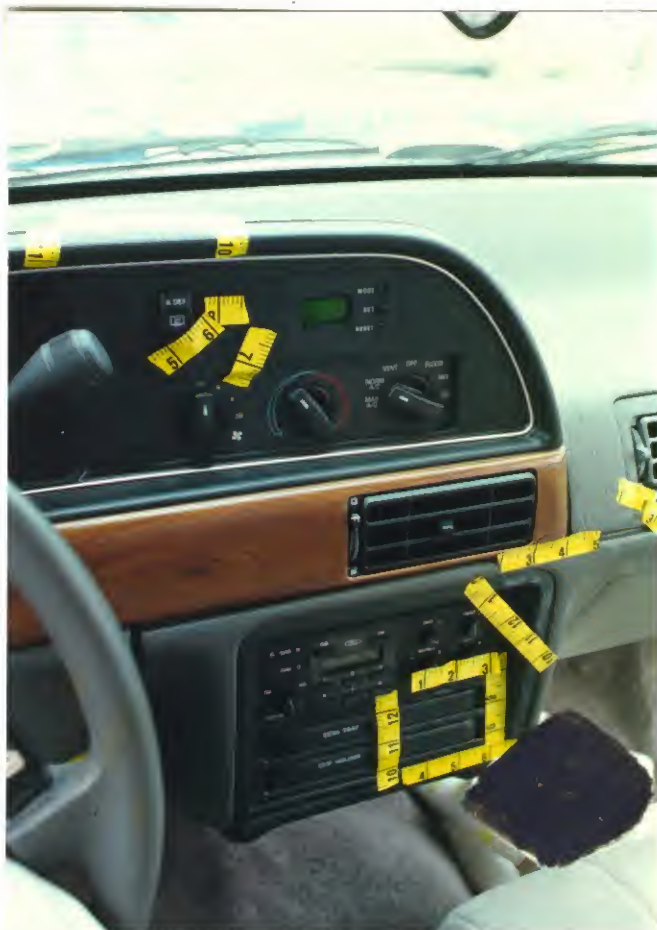
The center front occupant's extremities contacted the center instrument panel area, depositing fabric transfers to the contacted components. Her left arm contacted the upper instrument panel 4.25-6.75" left of center. Her right arm possibly contacted the upper panel at the rear defroster switch 3.75-4.5" left of center. A scuff mark evidenced the contact area and was located 2.5-3.1" below the top surface of the instrument panel. The center front occupant's knees contacted the mid and lower instrument panel in the areas of the air vents and cup holder. Fabric transfers extended 0-6.75" right of center and 8.75-12.75" below the top surface of the instrument panel.

Knee Contacts To The Lower  
Instrument Panel Area.

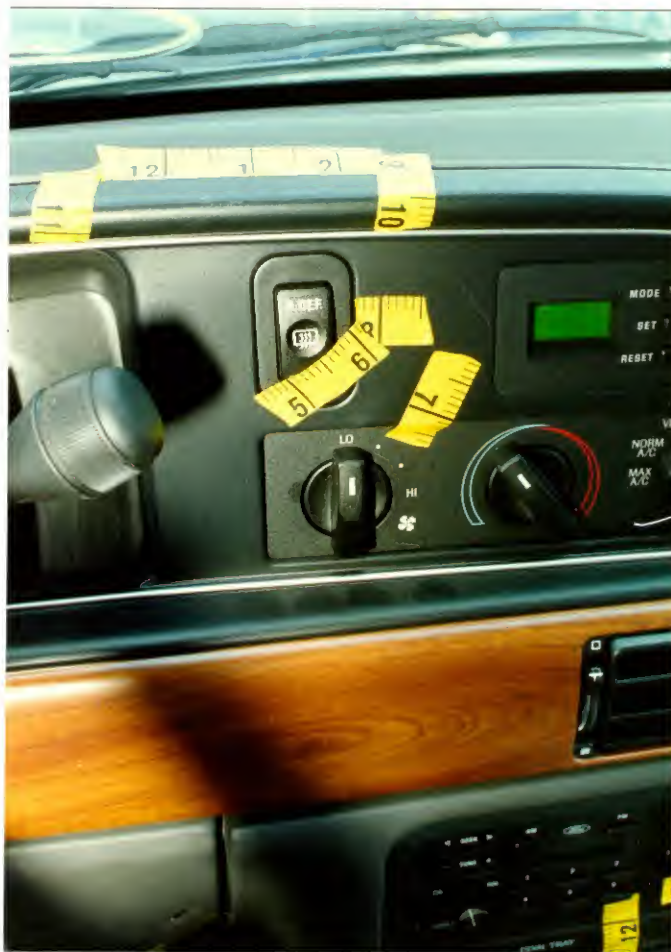
Hand Contact To The Center Upper Instrument Panel, Tissue Transfer.
